④ **WINDY KNOLL LAKE DAM**
⑤ **WARREN COUNTY, MISSOURI**
MO 30512

⑥ **PHASE 1 INSPECTION REPORT**
NATIONAL DAM SAFETY PROGRAM

WINDY KNOLL LAKE DAM
MISSOURI INVENTORY NO. 30512
WARREN COUNTY, MISSOURI

Date of Inspection: 9 June 1980

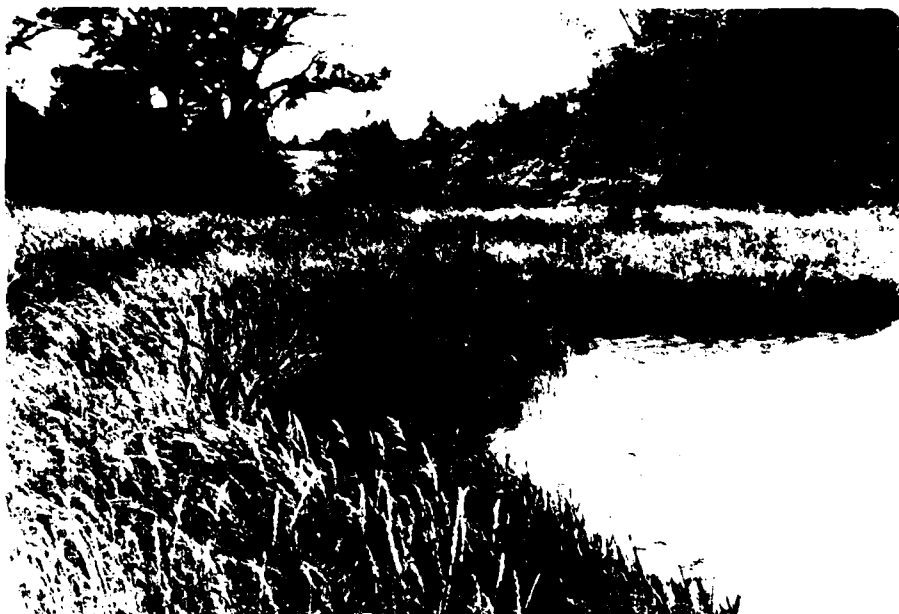
The excavated earth spillway (see Photos 3 and 4), except for some erosion of the invert at the junction of the spillway and the downstream channel, appeared to be in satisfactory condition. The invert of the spillway channel was protected from erosion by stone riprap up to about 6 inches in size. The eroded area of the channel was about 3 feet deep and up to 6 feet wide.

NO. 3: SPILLWAY APPROACH AND CREST
